***Evaluating VIA Ability and Diffusion Ability of Oil-base VCIs:
Cortec VpCI-326, 329, 322 and Mobilarma 247***

Project #: 10-048-1825(bis)

Date: June 22, 2010

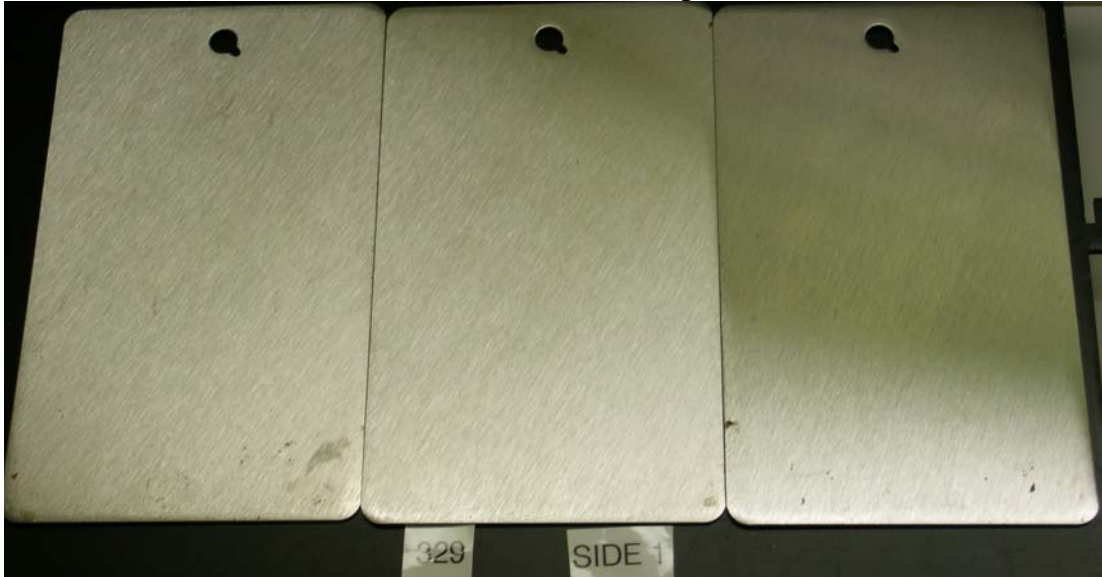
After 50ft Diffusion - VpCI-329

Inhibitor	% of surface corroded
VpCI-326	3
VpCI-329	3
VpCI-322	5
Mobilarma 247	2
No Inhibitor (control)	12

There is corrosion, though slight, on all panels placed in the after-50ft-diffusion boxes. Compared to the control, the panels in the after-diffusion boxes containing VpCI-322, VpCI-326, VpCI-329 and Mobilarma 247 showed some improvement,

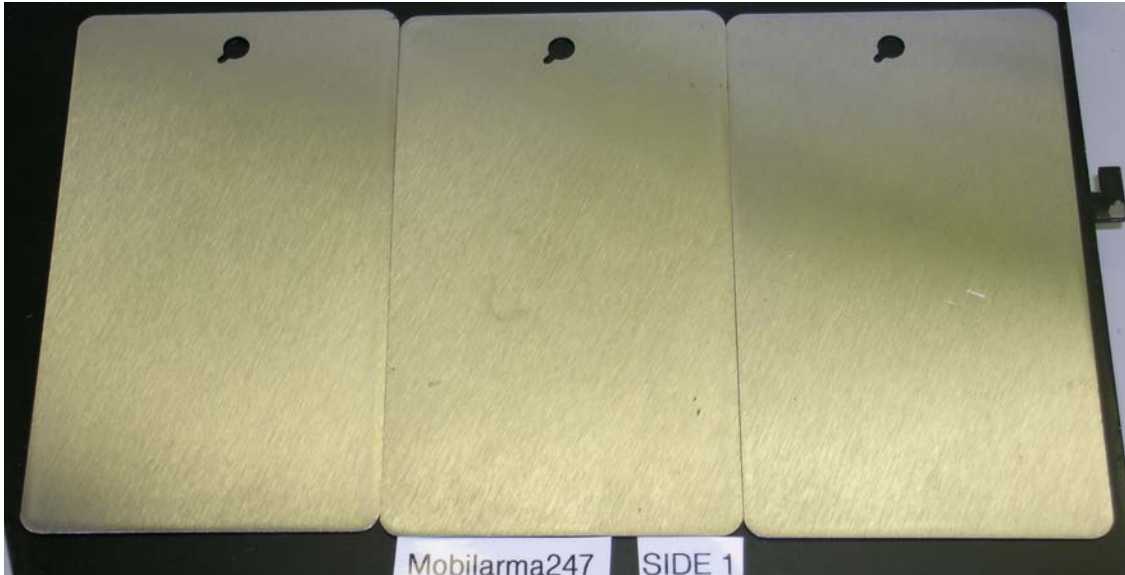
After 50 ft Diffusion –Mobilarma 247

The results of these tests also make us believe that Mobilarma 247 oil contains a mixture of ingredients with different vapor pressure and corrosion activities. The less volatile compound cause significant corrosion in the first test and this might happen in some industrial applications.
