## *Evaluating Rust Preventive Options*

**Project #:** 11-083-1825(bis)

**Date:** May 24, 2011

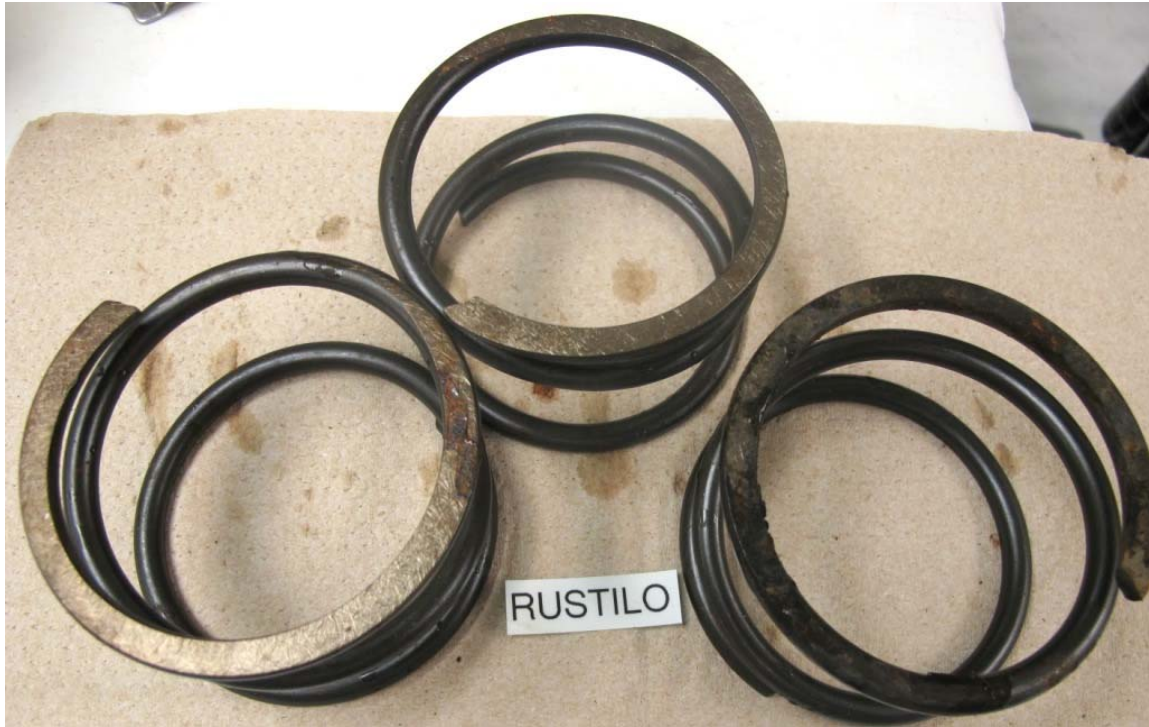
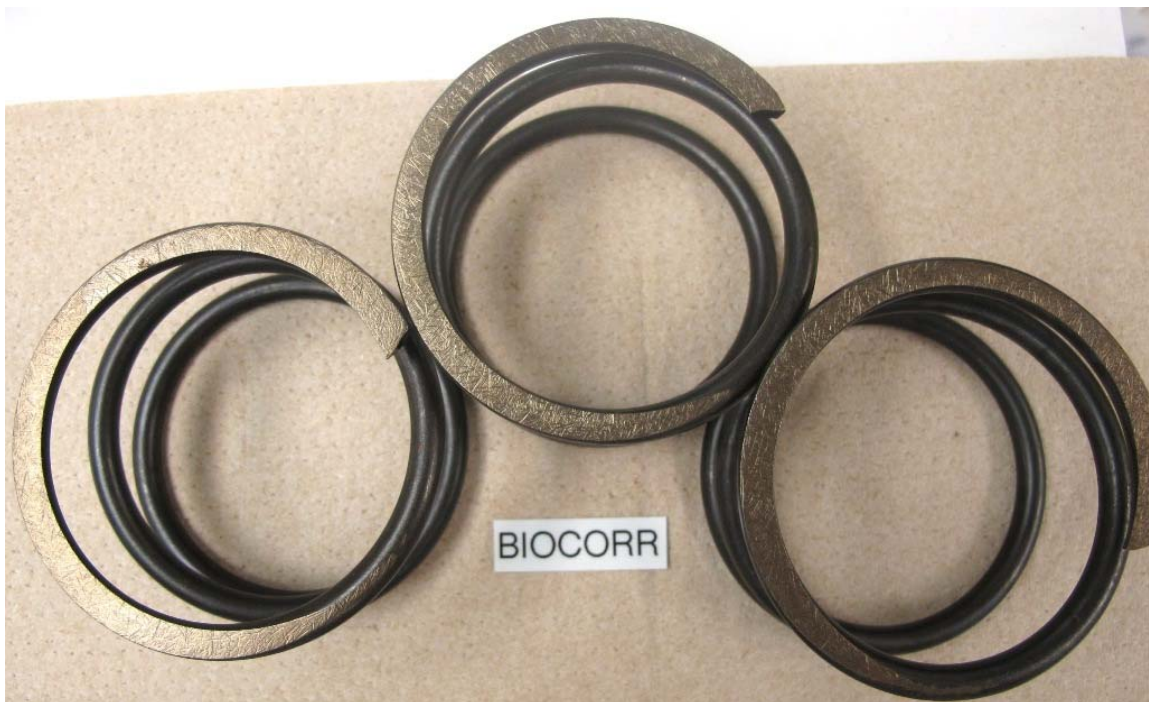
**Photos:**

**Interpretations:** After over 900 hours in accelerated corrosion testing, BioCorr provided superior protection to Rustilo 4135 HF on springs.

No visible corrosion was present on the edges of either set of snap rings.

Part ID/Treatment	Time to Corrosion (Hours)
Springs/Rustilo	600
Springs/BioCorr	DNF*
Snap rings/Rust Veto	DNF*
Snap Rings/VpCI-337	DNF*
