Evaluating Rust Preventive Options

Project #: 11-150-1825(bis)

Date: August 12, 2011

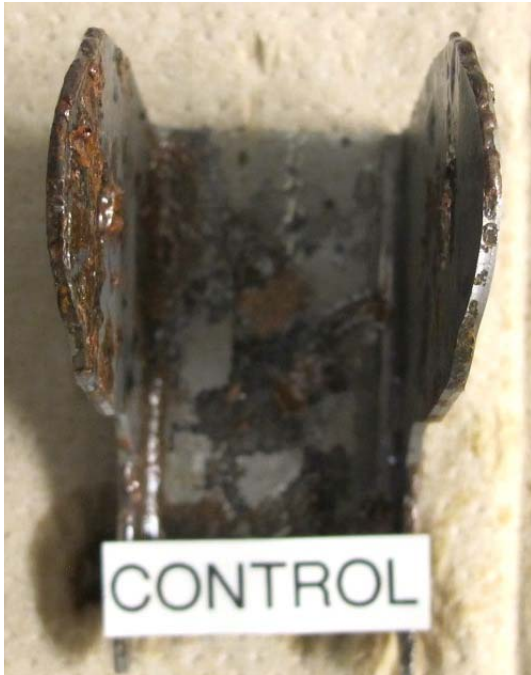
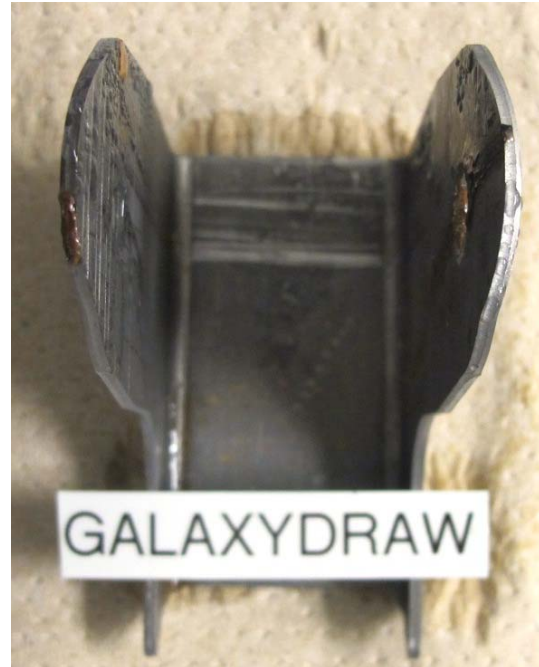
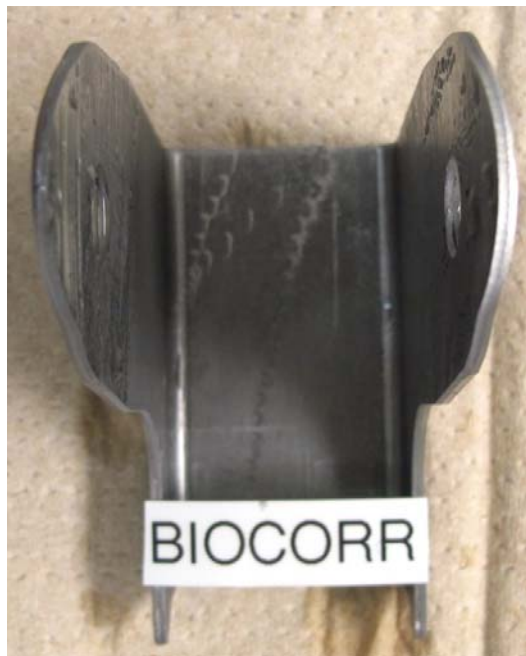
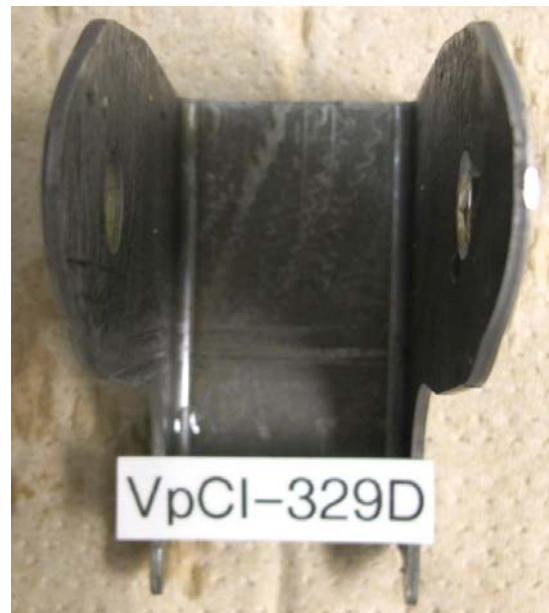
Photos:

Rust Preventive	Time to Corrosion (Hours)
None (control)	<24
Galaxydraw 790	288
BioCorr SC (10%)	DNF
VpCI-329D	DNF

Interpretations: After 336 hours of ASTM D-1748 humidity testing, both BioCorr SC (10%) and VpCI-329D had provided complete corrosion protection on stampings. In comparison, the stamping protected by Galaxydraw had started to corrode after 288 hours.
