Determination of Best Rust Preventative on Steel Rods

Project #: 12-222-1825.bis

Date: October 29, 2012

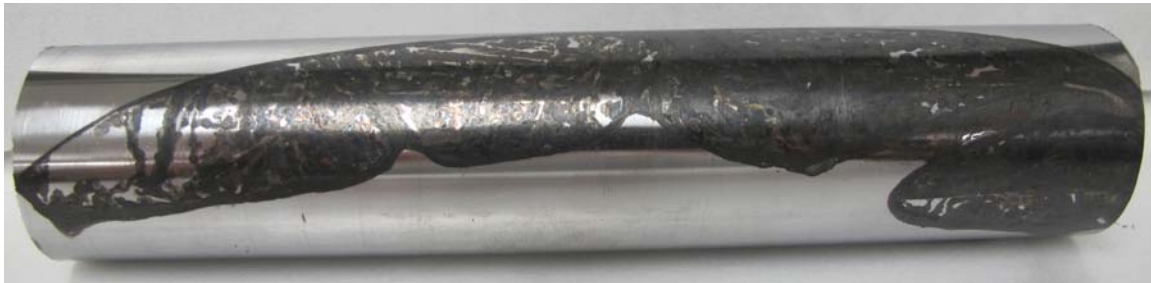
Figure 1: No Rust Preventative (Control)

| Rust Preventative | Time Until Failure (Hours) |
|---|---|
| None (Control) | < 24 |

After 240 hours of humidity testing VpCI-325 performed the best according to both failure time and visual inspection. Ecoline 3690 provided the next best protection, with only 3 minute corrosion spots after 240 hours of testing. Both BioCorr and Wallover RP slightly outperformed the part with no rust preventative. From these results it is apparent that a water based rust preventative is not suitable for long term corrosion inhibition on these highly polished steel rods.

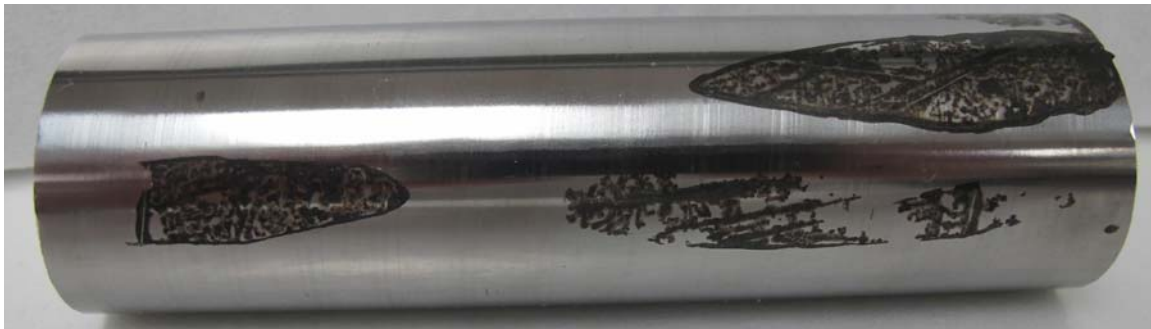
Figure 2: BioCorr

| Rust Preventative | Time Until Failure (Hours) |
|---|---|
| BioCorr | 144 |

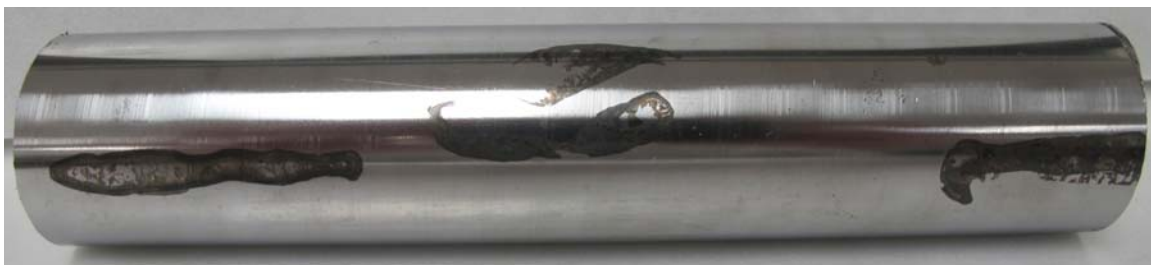
Figure 3: Wallover RP

| Rust Preventative | Time Until Failure (Hours) |
|---|---|
| Wlover | 72 |

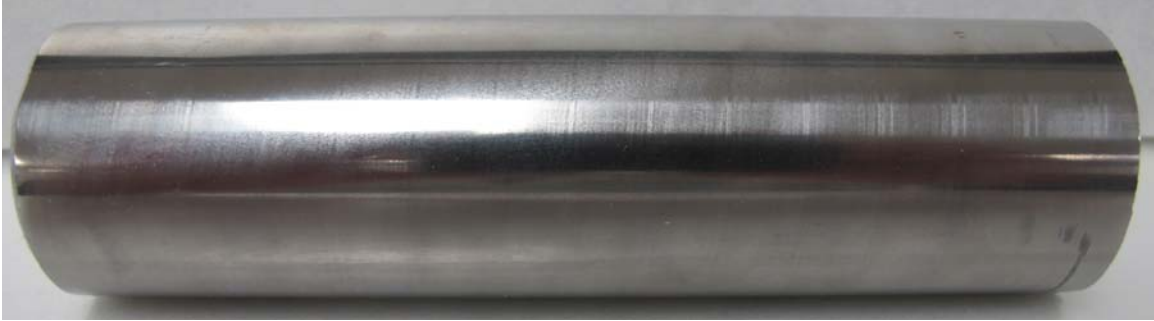
Figure 4: Ecoline 3690

| Rust Preventative | Time Until Failure (Hours) |
|---|---|
| Ecoline 3690 | 240 |

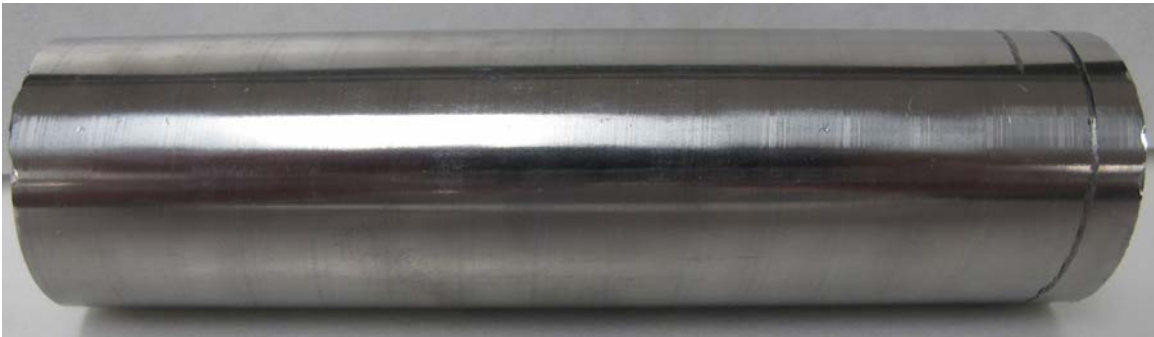
Figure 5: VpCI-325

| Rust Preventative | Time Until Failure (Hours) |
|---|---|
| VpCI-325 | DNF* |
