Testing Corrosion Protection of Water Based Rust Preventatives

Project #: 12-242-1825.bis

Date: January 11, 2013

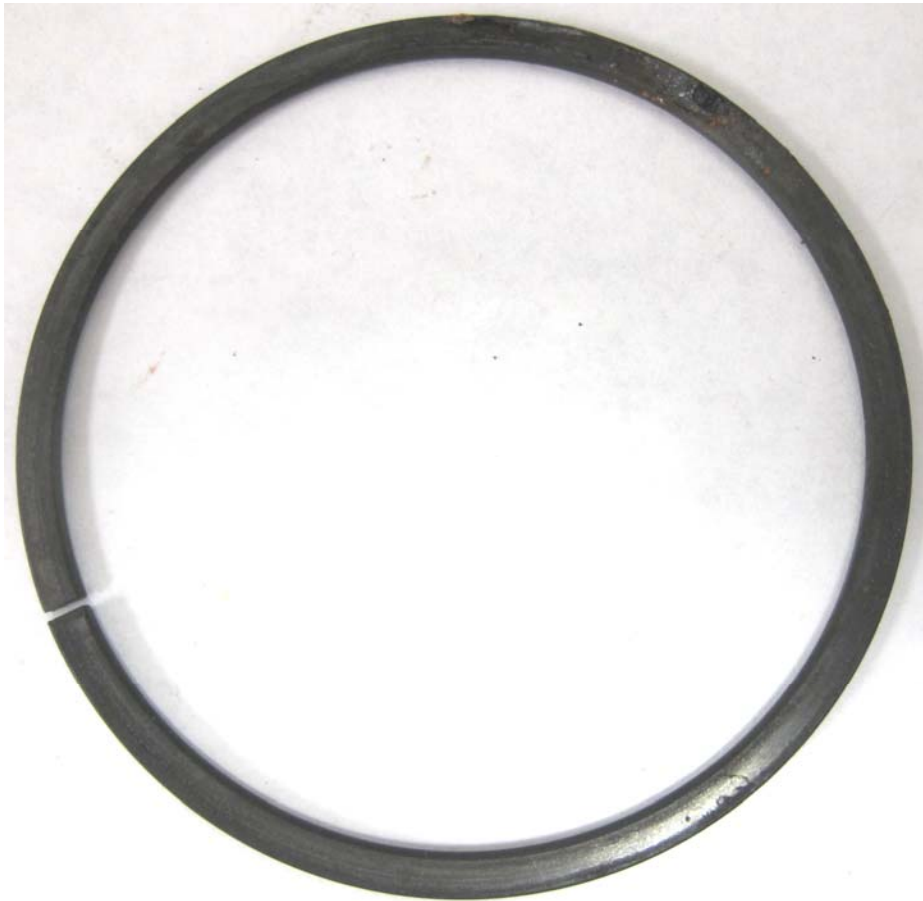
Figure 1: International Chemical 152 coated part after 600 hours of testing

Parts coated with BioCorr and VpCI-377 at 5% dilution both protect these steel rings better than the parts pre-coated with International Chemical 152. The average failure time of the pre-coated parts was 456 hours. BioCorr and VpCI-377 at 5% dilution did not fail during 600 hours of testing. The photos below verify the results. It should be noted that the dark color of the pre-coated parts makes it difficult to see the pitting and black oxides. Also, the small spots of corrosion on the BioCorr and VpCI-377 parts are where the plastic coated paper clip was supporting the part.

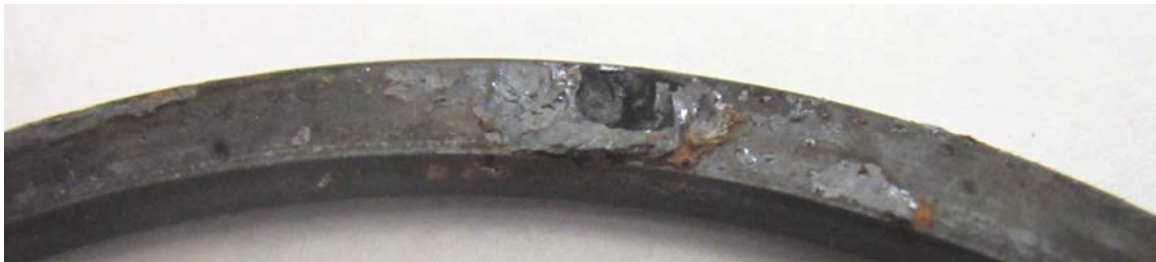
Figure 2: Close up of International Chemical 152 coated part to show corrosion

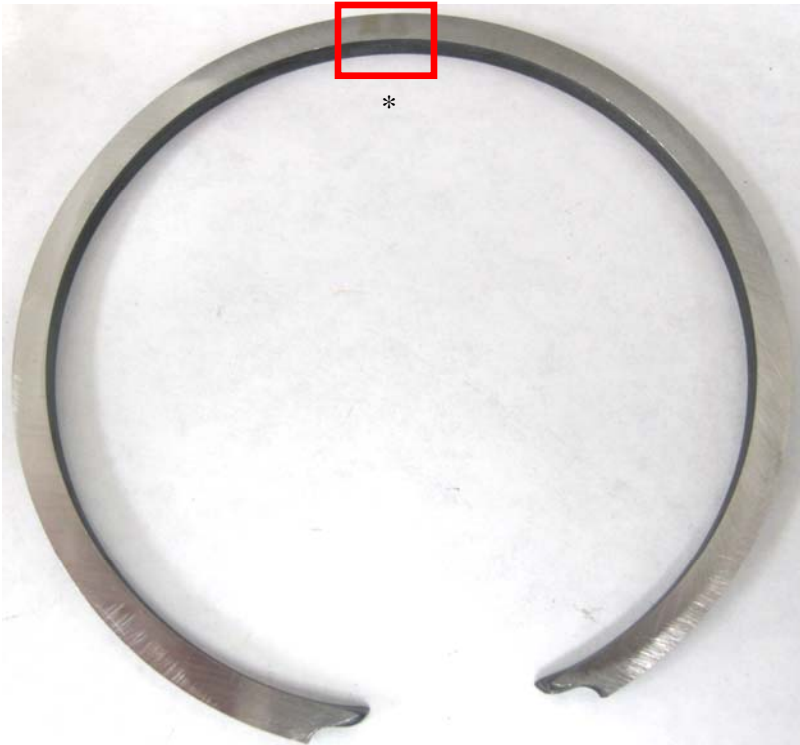
Figure 3: Part Coated with VpCI-377

* Red boxes indicate spot of corrosion. In each case the plastic coated paper clip supporting the part was in contact with this area.

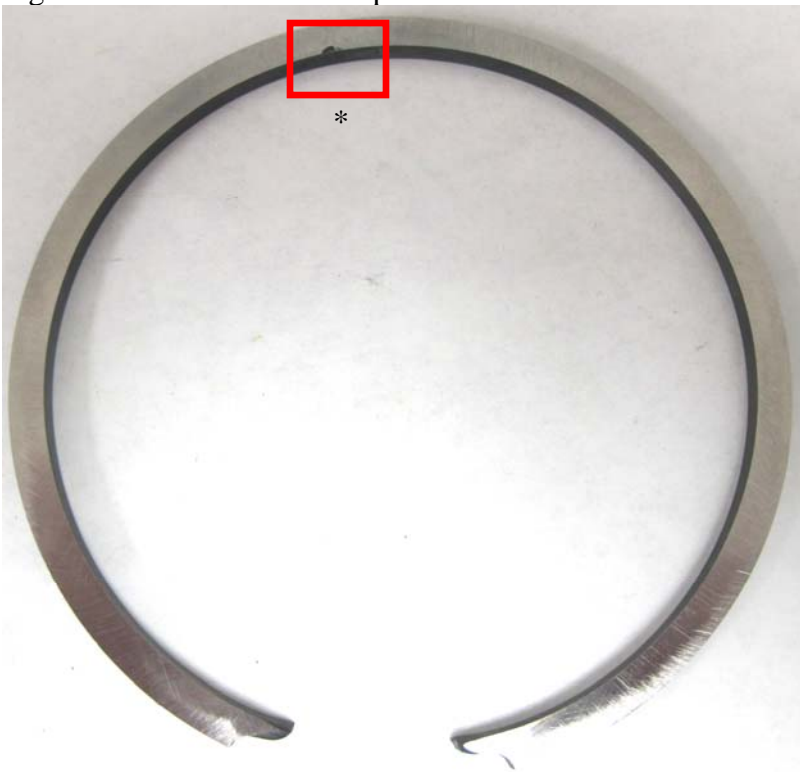
Figure 4: Part Coated with BioCorr Rust Preventative
