Comparison of VpCI-325 and Fuchs RP on Camshaft Parts

Project #: 13-018-1825.bis

Date: February 26, 2013

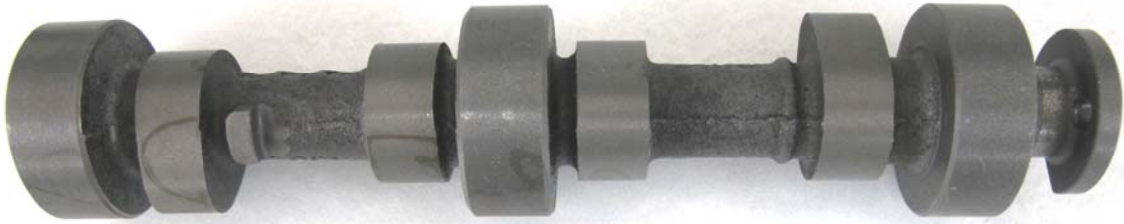
Figure 1: Part 1 protected with VpCI-325

According to the testing completed, VpCI-325 is a better rust preventative for the provided parts than the Fuchs Lubricants product. The parts treated with VpCI-325 did not fail until 312 hours in ASTM D-1735 testing, while the other parts failed at 192 hours. This is further confirmed by the photos of the parts after 360 hours of testing, as seen below.

The following photos were taken after 360 hours of testing:

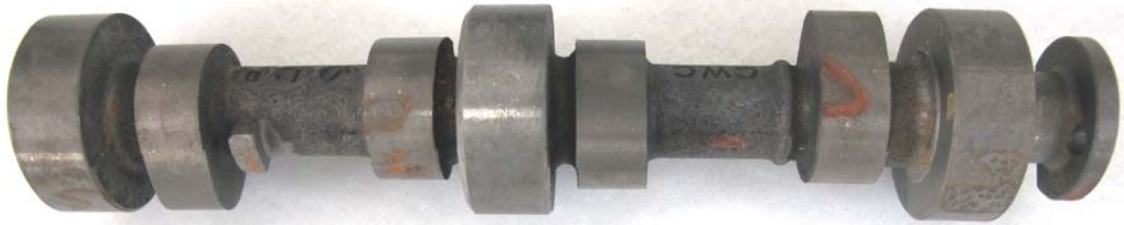
Figure 2: Part 1 protected with Fuchs RP

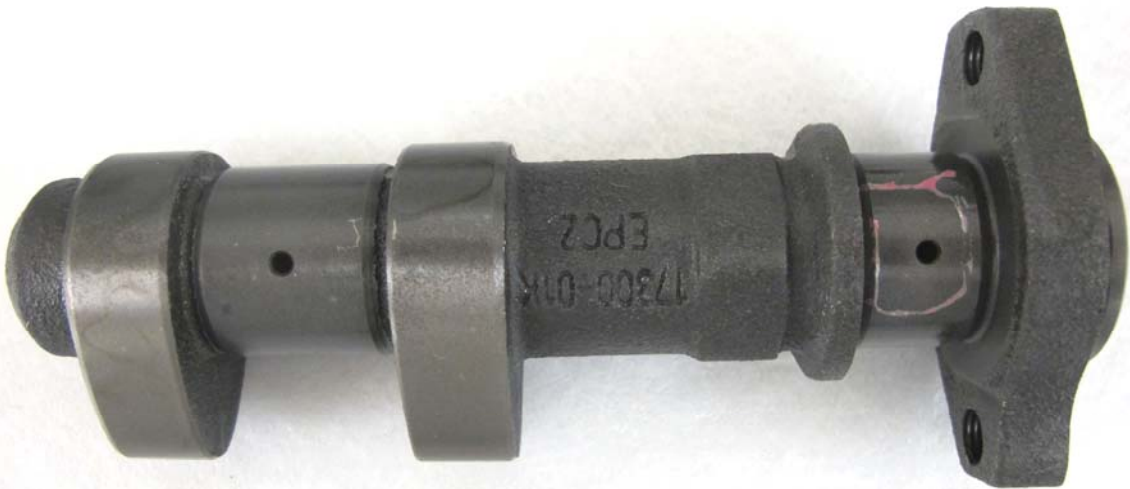
Figure 3: Part 2 protected with VpCI-325

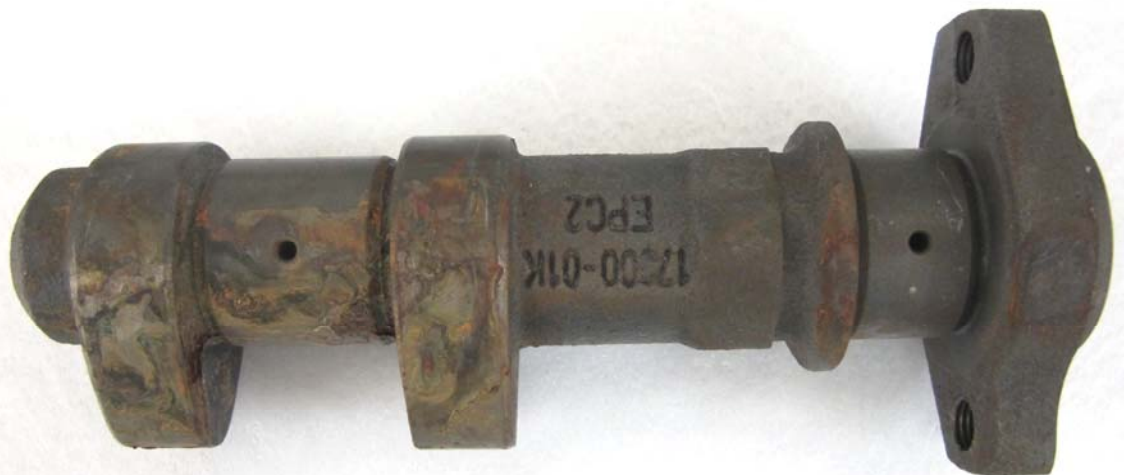
Figure 4: Part 2 protected with Fuchs RP

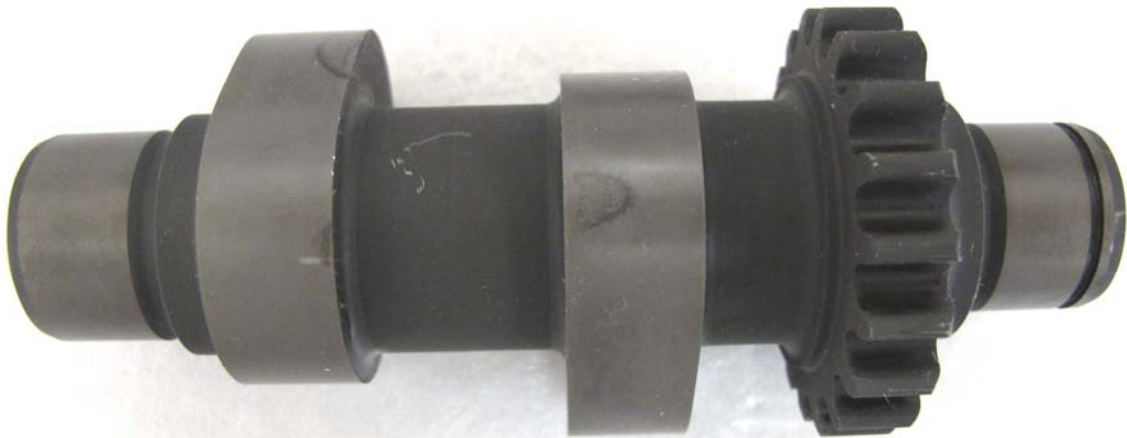
Figure 5: Part 3 protected with VpCI-325

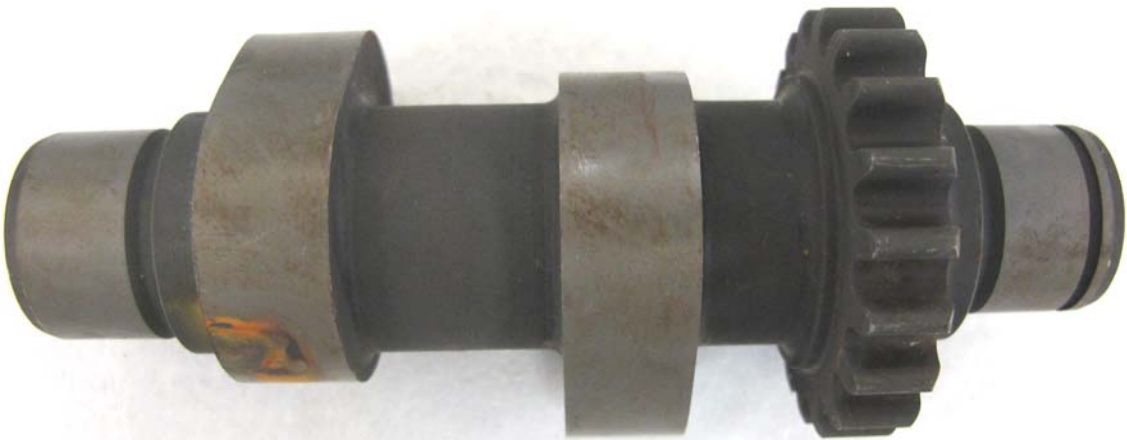
Figure 6: Part 3 protected with Fuchs RP
