*Evaluating Rust Preventive Liquids on  
Clutch Plates from Customer*

**Project #:** 15-260-1825.bis

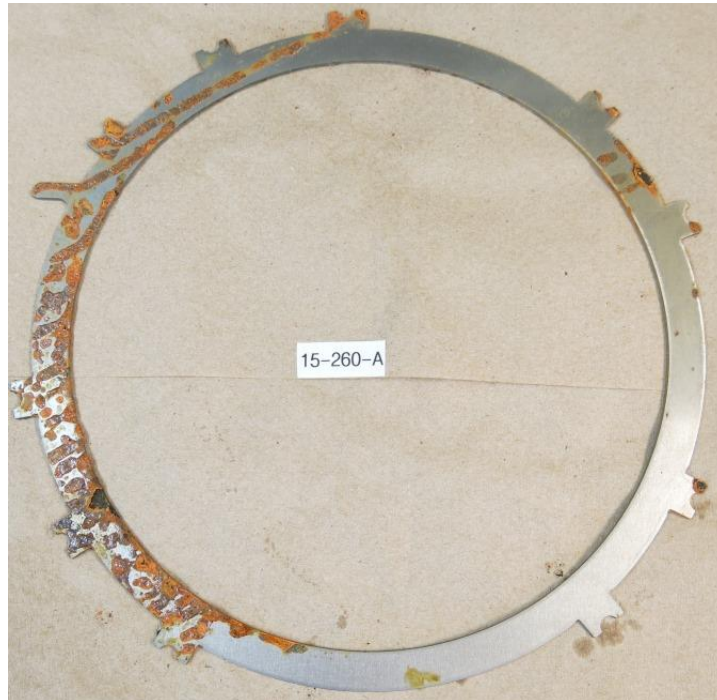
Figure 1: Control clutch plate, after 624 hours of testing.

Metal Treatment	Time to Corrosion (Hours)
A - None (Control)	24
B - Kyzen CP90D	460
C - VpCI-325	624
D - VpCI-329D	528

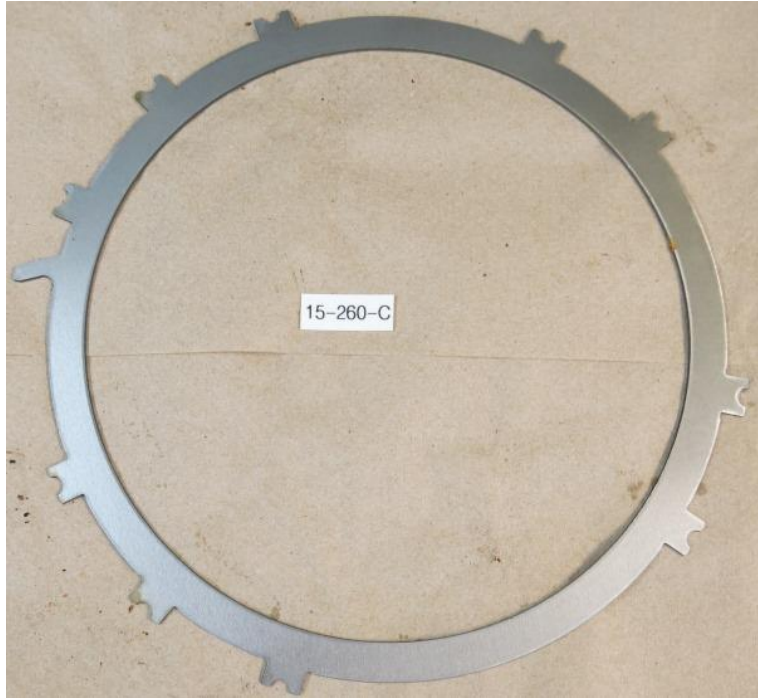
Figure 3: VpCI-325 treated clutch plate, after 624 hours of testing.

**Interpretations:** After 624 hours in ASTM D-1735 Water Fog testing, VpCI-325 was the most effective rust preventive solution for clutch plates from customer. VpCI-329D was also more effective than the incumbent solution, Kyzen CP90D.

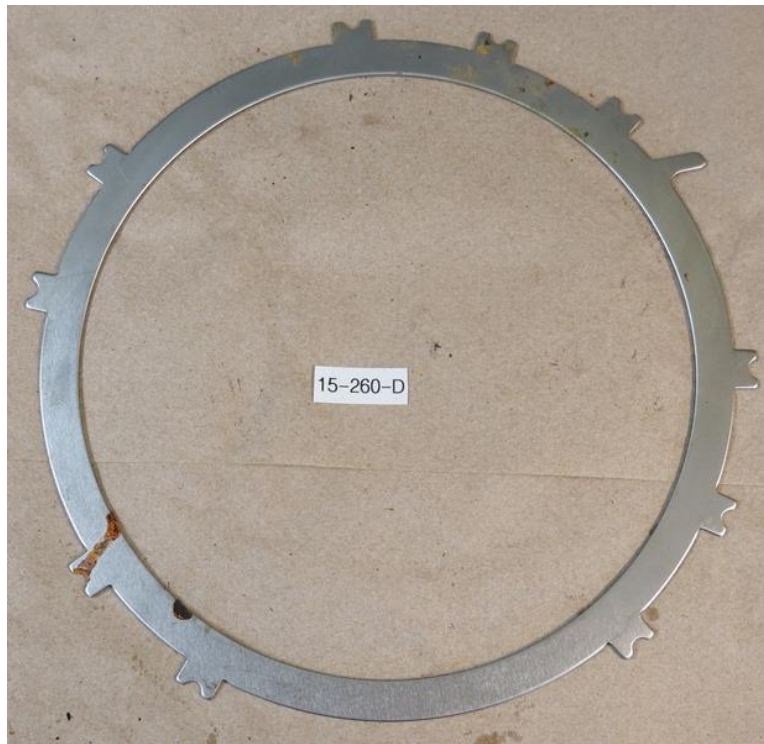
Figure 4: VpCI-329D treated clutch plate, after 624 hours in testing.
