## *Evaluation of VpCI-377 for Customer*

**Project #:** 05-239-1825

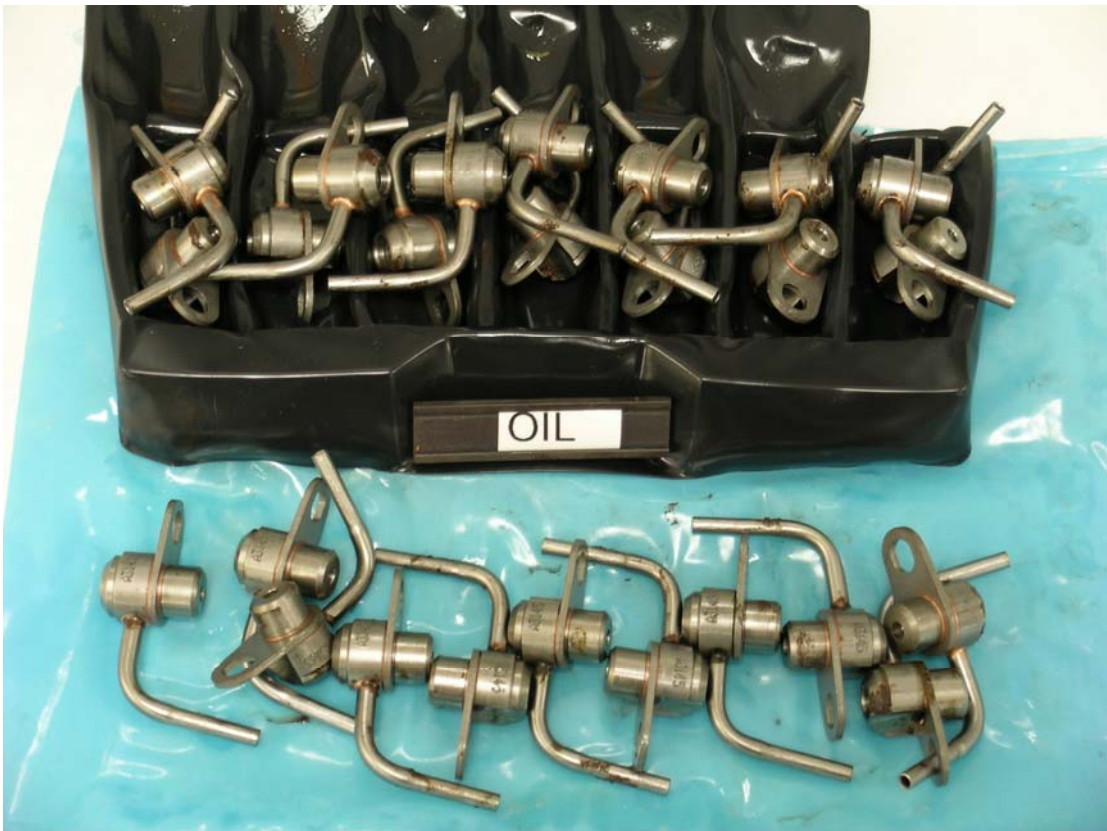
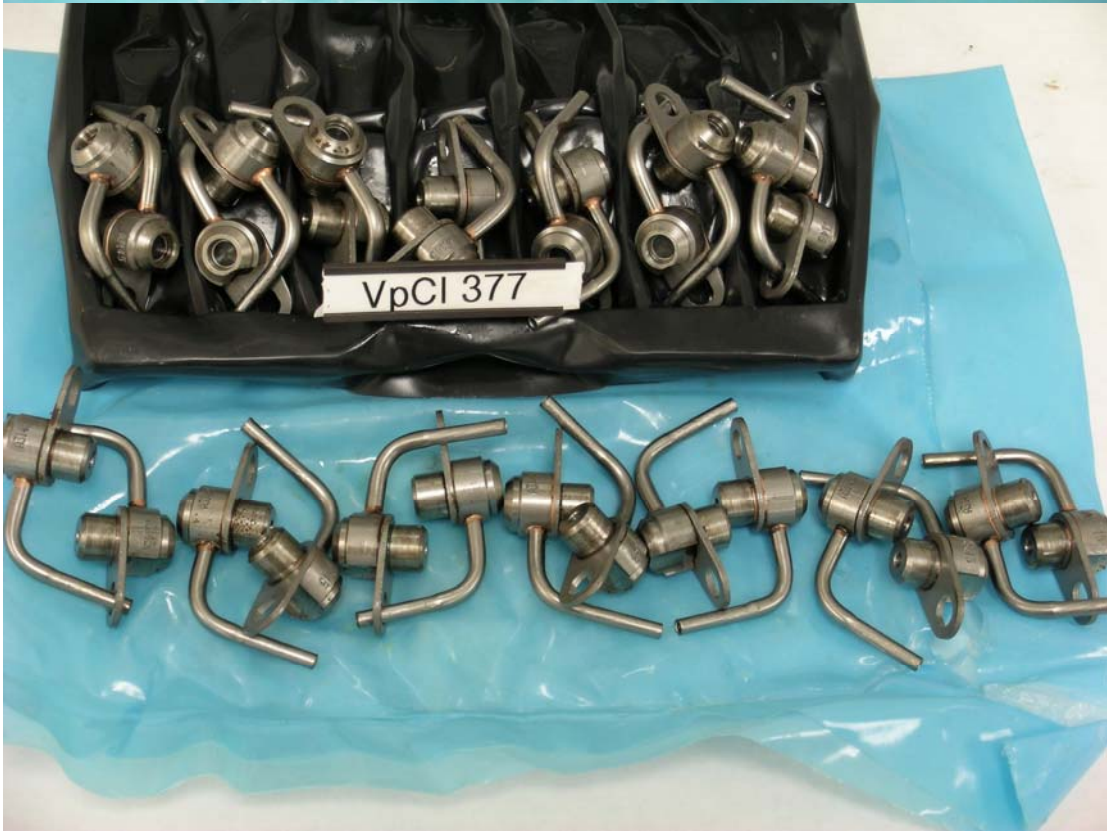
**Results:** Less than 1% of the total surface area of the components treated with VpCI-377 and wrapped in VpCI-126 Blue film was corroded.  
Greater than 10% of the total surface area of the components treated with the Fuchs oil and wrapped in VpCI-126 Blue film was corroded.

**Conclusion:** VpCI-377 greatly outperformed the Fuchs oil when utilized with the VpCI-126 Blue film for the corrosion protection of the components tested. The synergy between Cortec products was clearly evident by the tenfold decrease in corrosion between the sample with VpCI-377 and the sample treated with the Fuchs oil.
