Evaluation of Multan F5002 Part 1

Project #: 06-219-1125

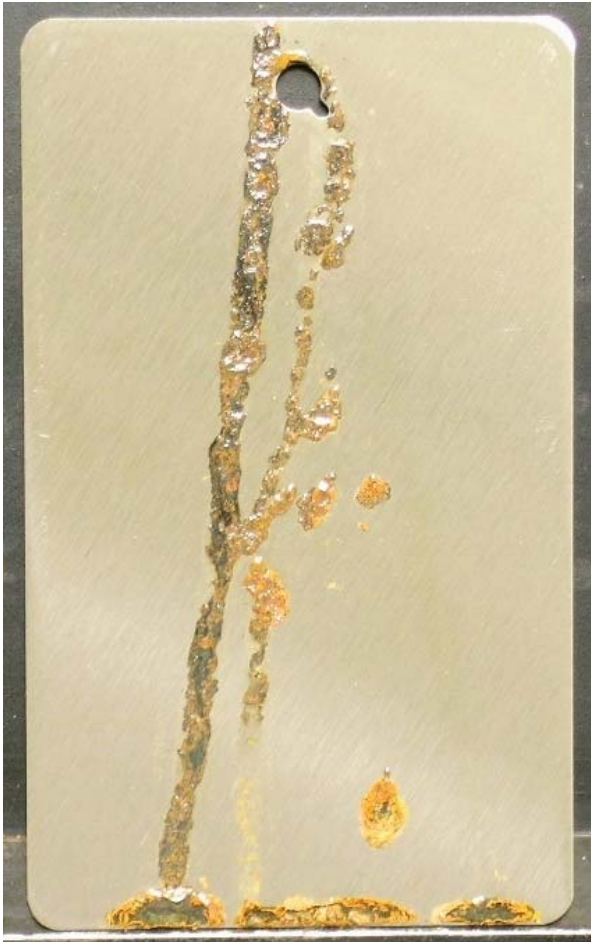
Picture after 215 hours

Multan F5002 (control)

Sample Description	Time to Failure
Multan F5002 (control)	20 hours
Multan F5002 + 5% M-370	210 hours

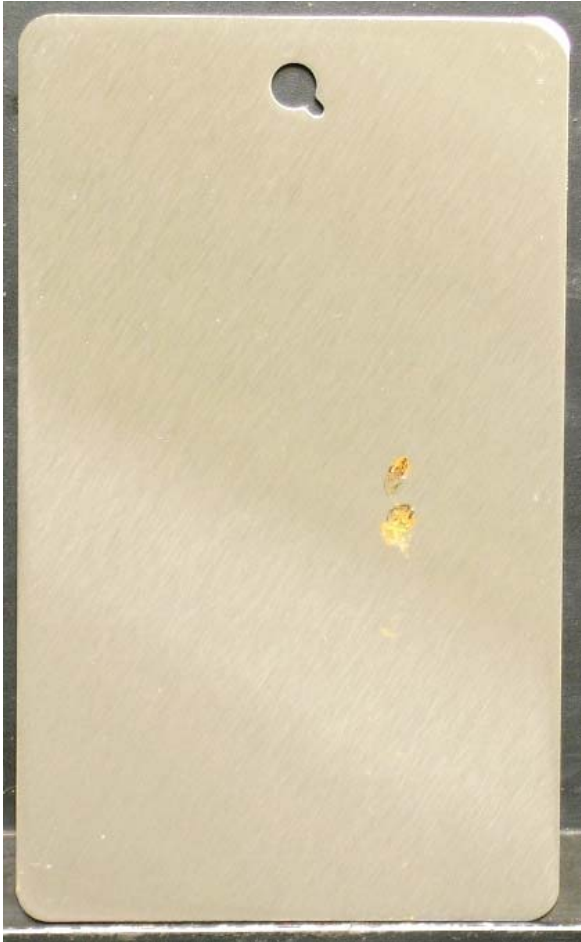
Multan F5002 + 5% M-370

Conclusion: M-370 at a concentration of 5% is an excellent anticorrosion additive to Multan F5002 that significantly improves corrosion protection. In the second part of this project, the replacement of Multan F5002 will be recommended.
