Evaluating Packaging Systems for Parts from Customer

Project #: 07-103 (bis)

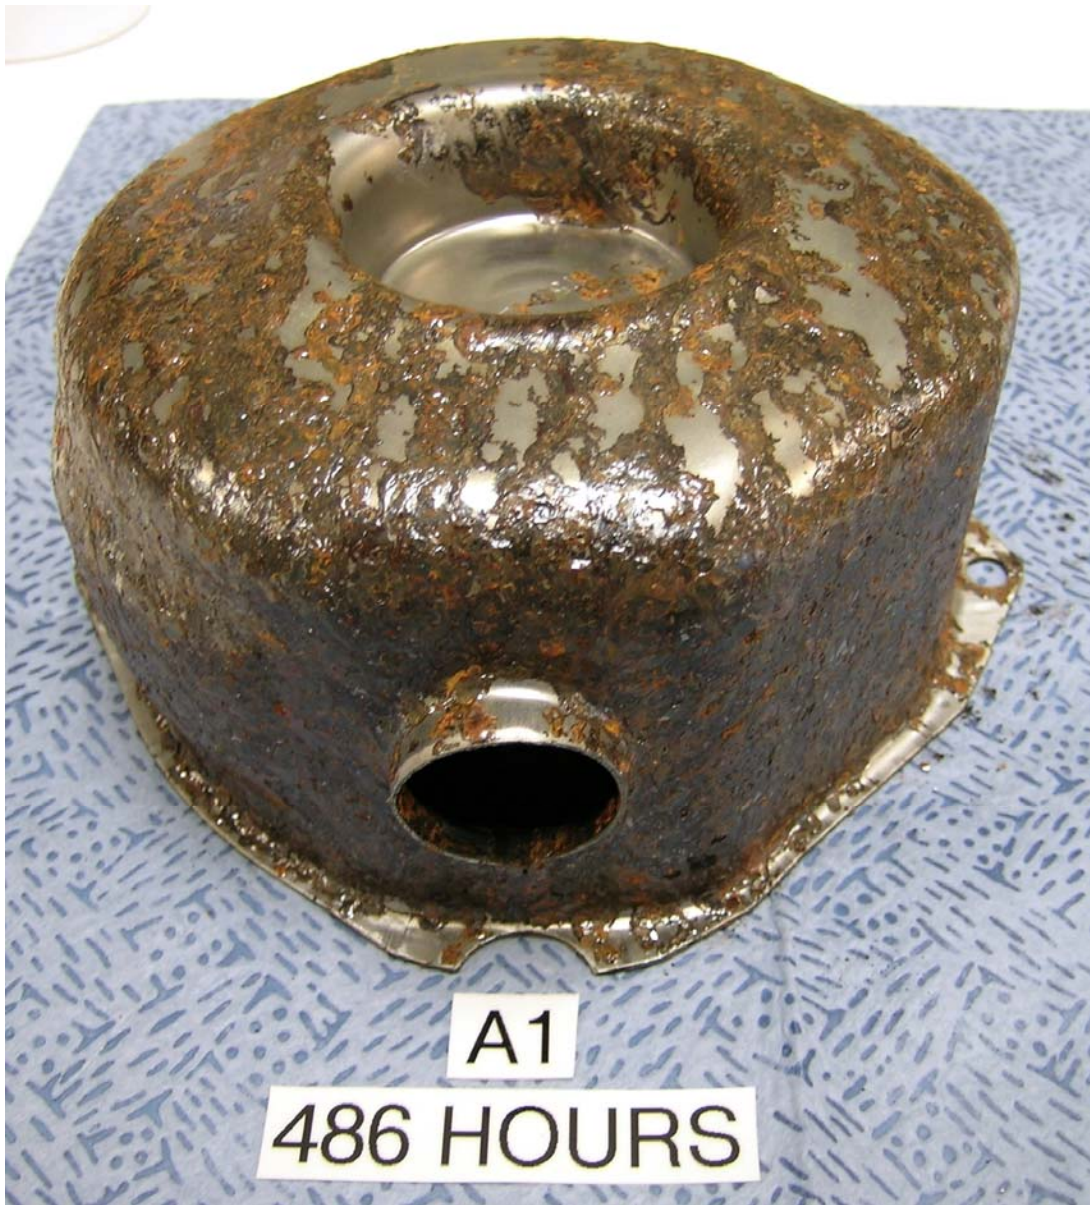
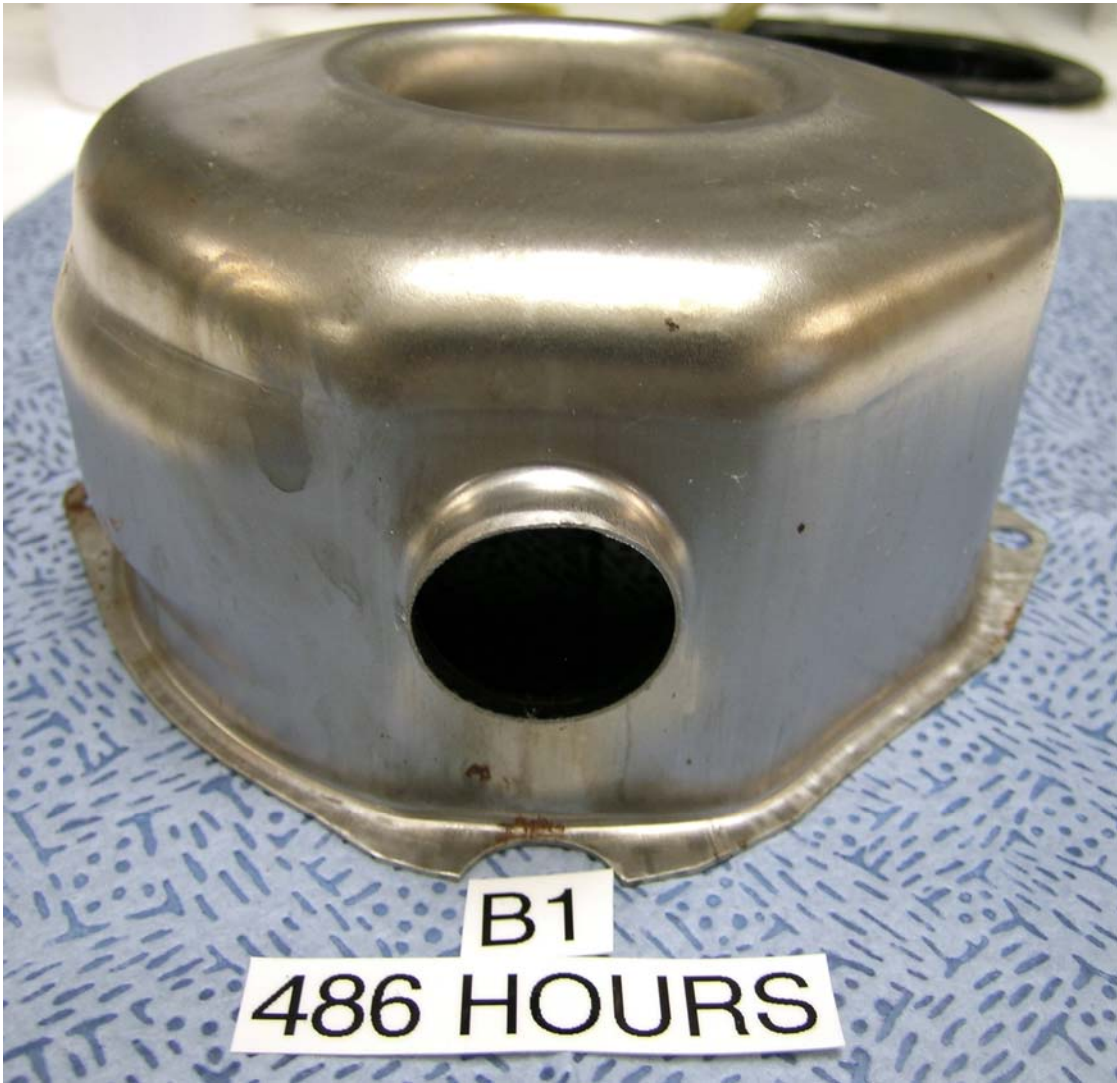
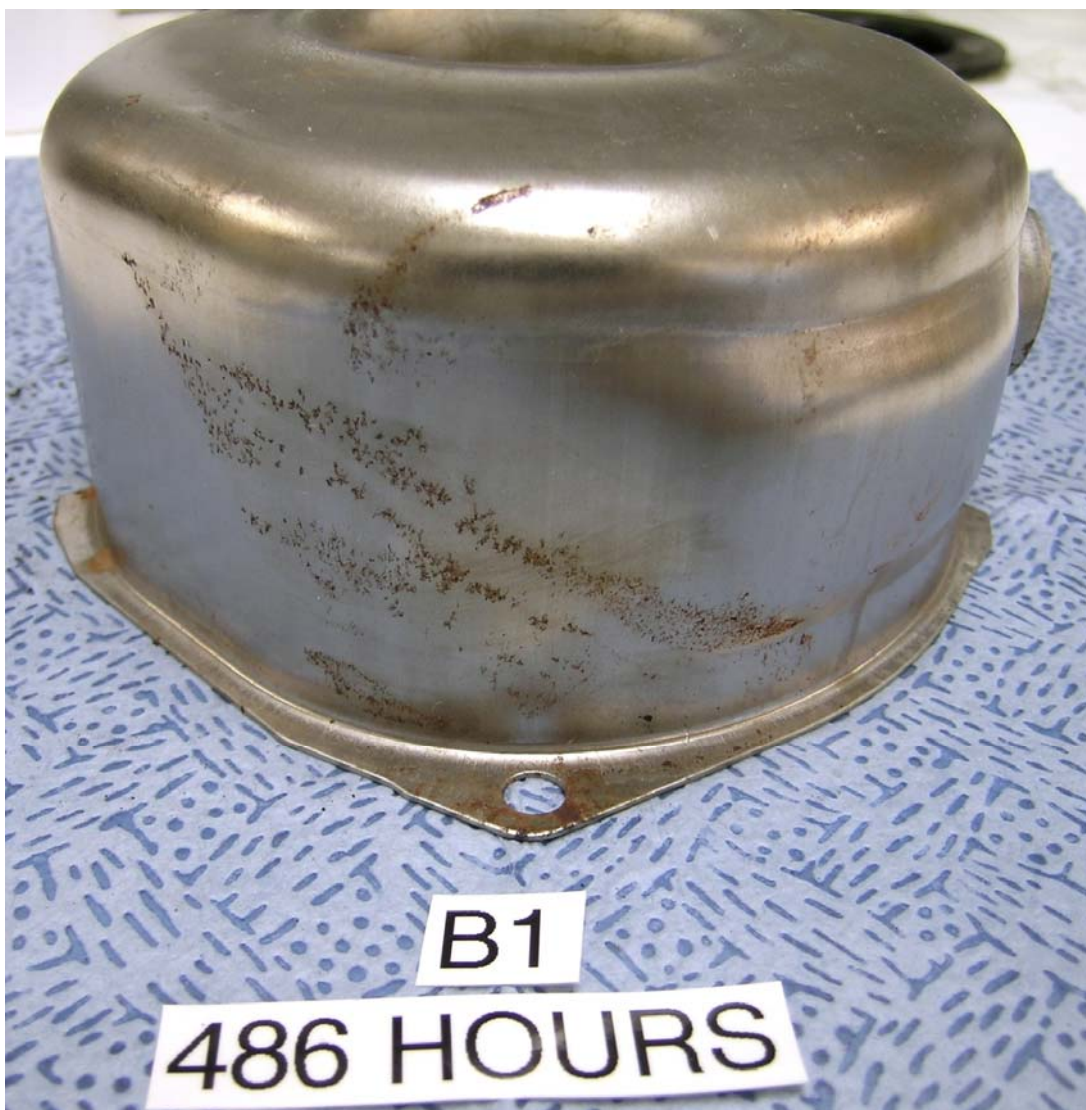
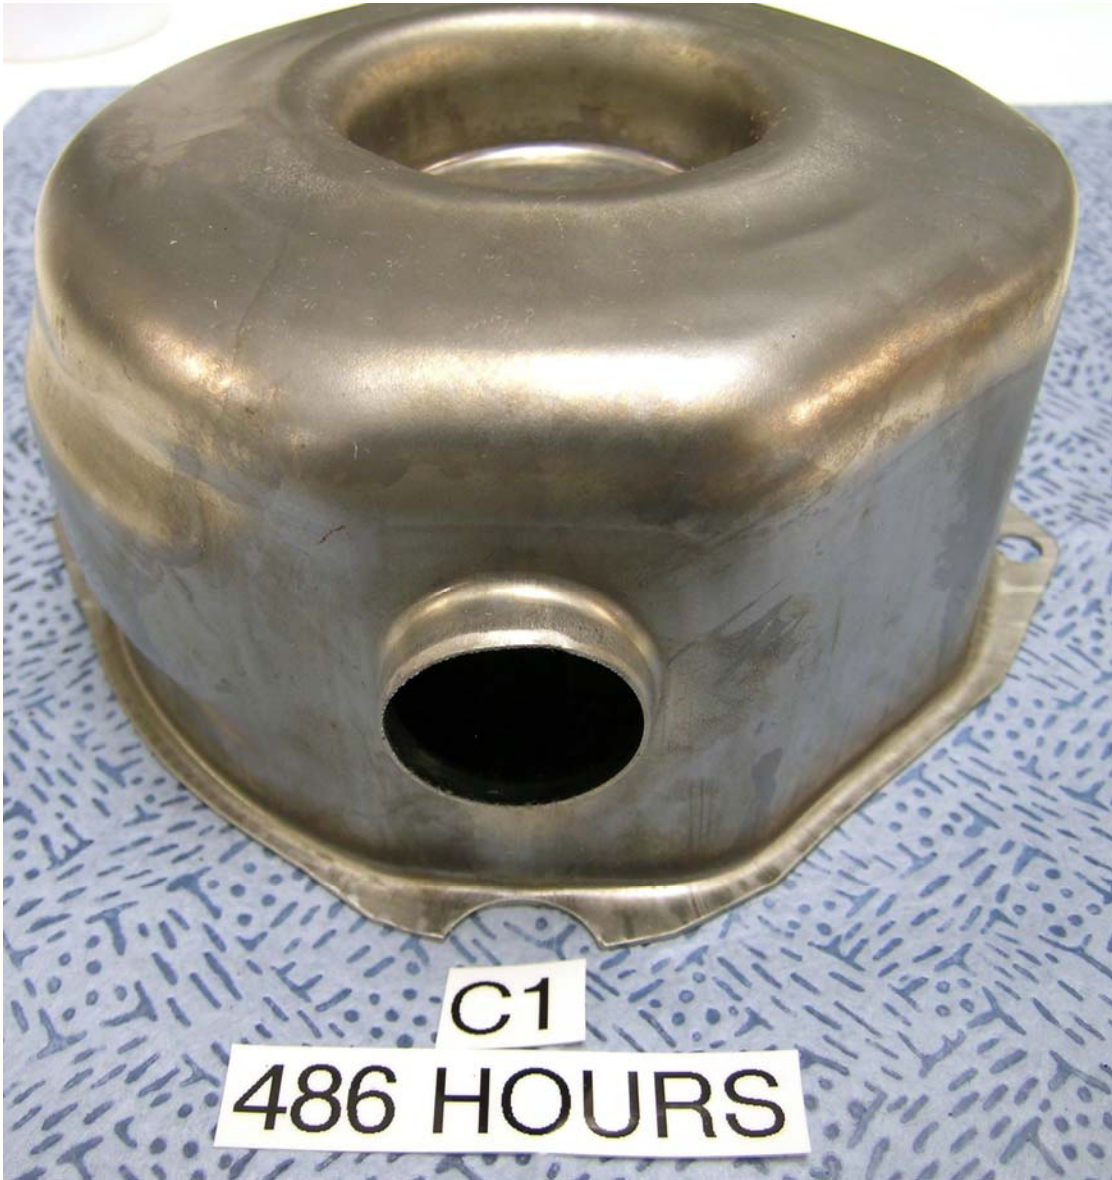
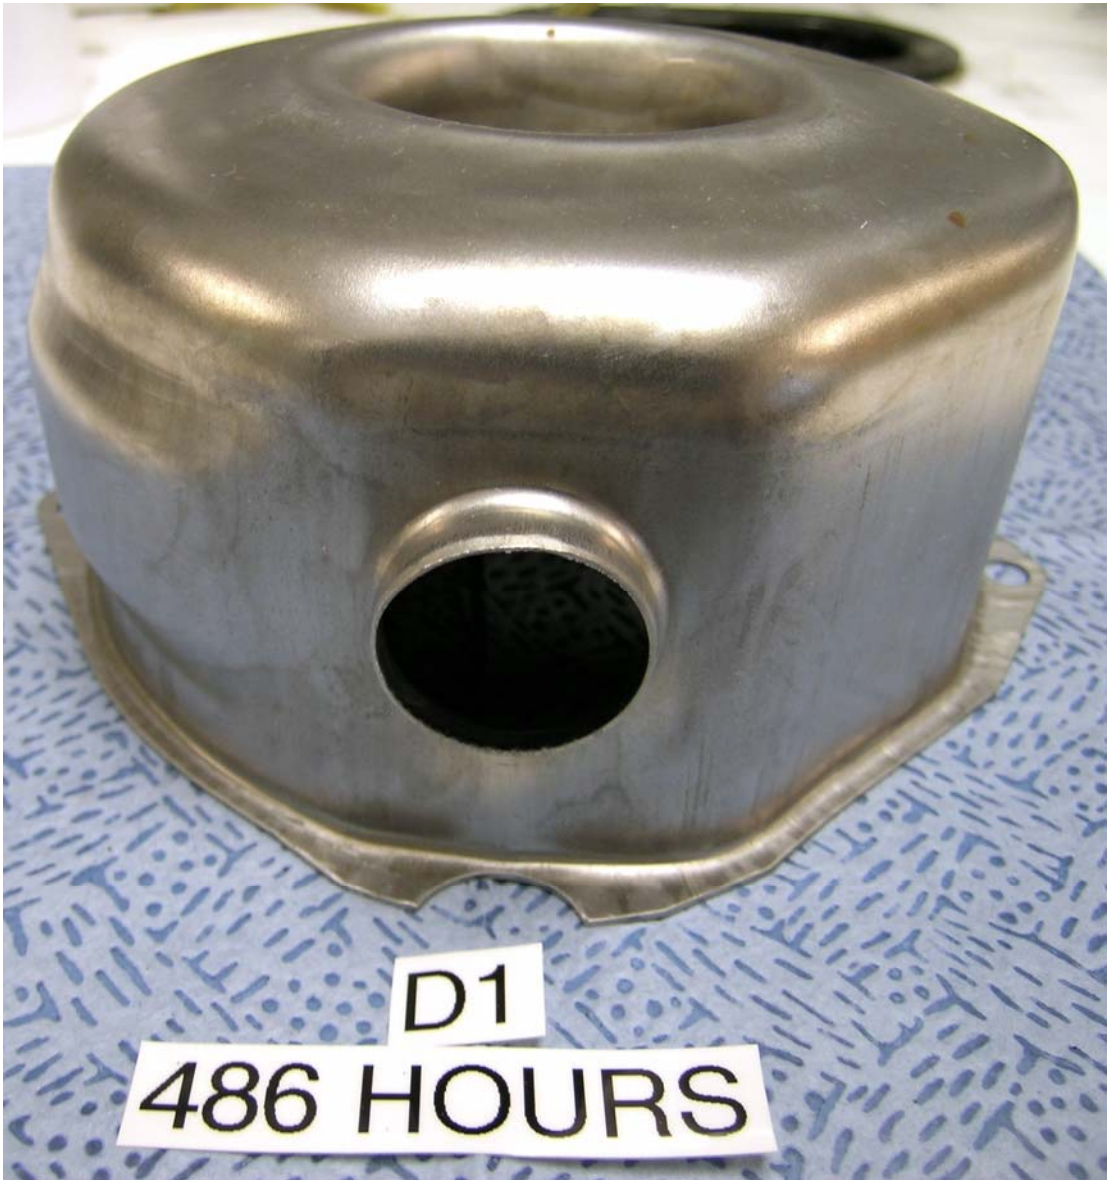
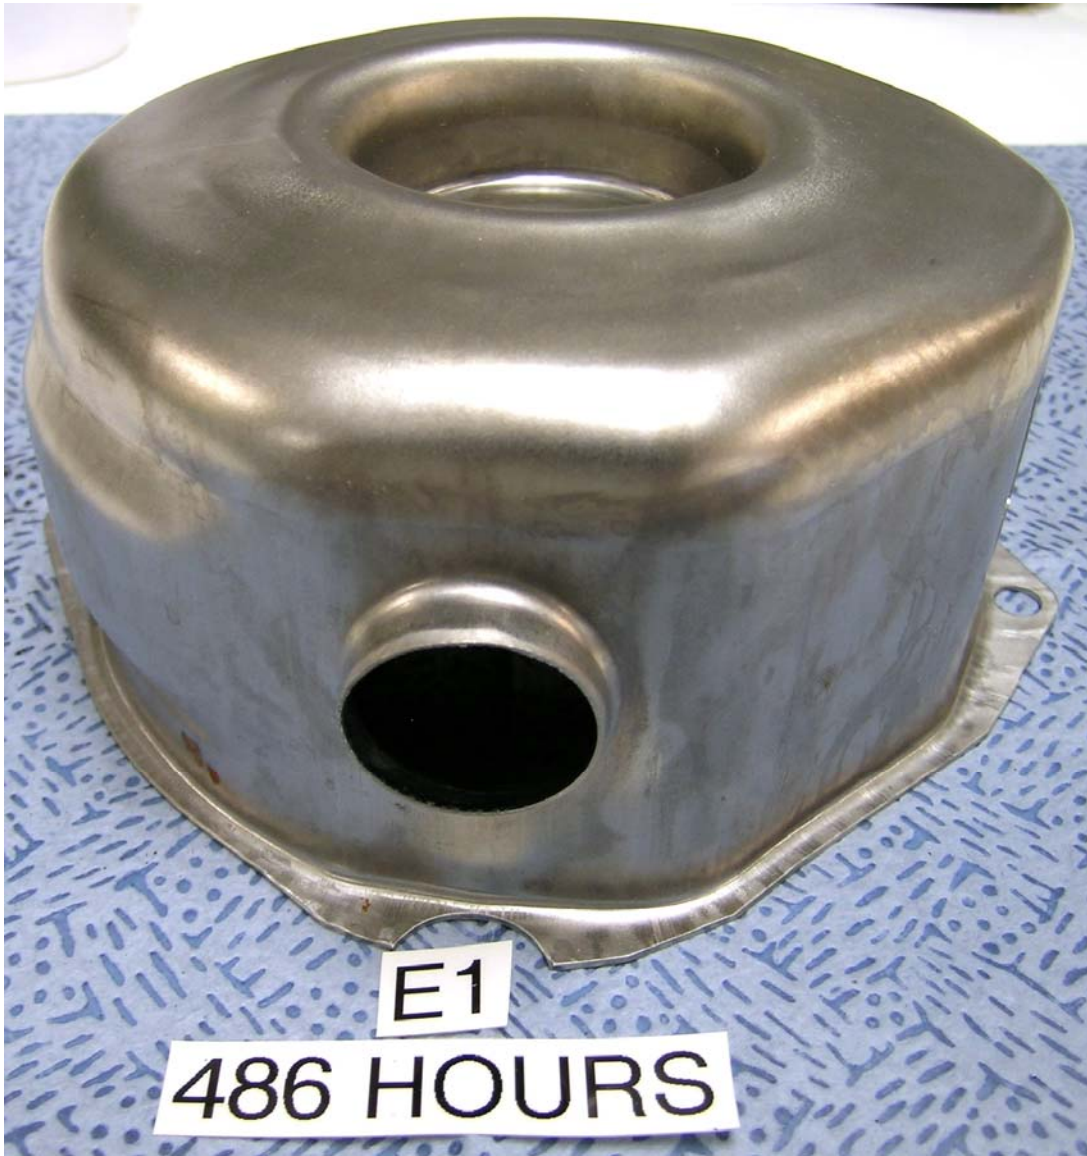
- 5) After packaging, all parts were allowed to condition.
- 6) After conditioning, all parts were placed in the ASTM D 1748 Humidity Cabinet.
- 7) Parts were visually inspected periodically.
- 8) After 486 hours, parts were removed from ASTM D 1748 Humidity Cabinet.
- 9) Parts were visually inspected and photographed.

Part	Time to Failure (Hours)	% Corrosion
A1	<24	>90%
B1	288	<5%
C1	DNF	<1%
D1	DNF	<1%
E1	DNF	<1%

Conclusion: The Circle Proscro A310 liquid provided very little protection in humidity testing. VpCI-126 blue film performed well as a stand alone product, with corrosion on less than 5% of the wrapped part. When used in combination, VpCI-126 and Circle Proscro liquid provided excellent protection. The packages that included VpCI-130 foam and VpCI-146 paper provided excellent protection as well.
