## ***Comparing Corrosion Protection of VpCI-377 and Richclean 10-65A Used by Systrand Manufacturing***

- Background:** Systrand Manufacturing specializes in a variety of metal manufacturing processes, including cast iron, steel forging, and die cast aluminum. Systrand currently uses Richclean 10-65A as a cleaner/rust preventative for their parts, and they have been having corrosion issues. The corrosion protection of the Richclean product will be compared to VpCI-377.

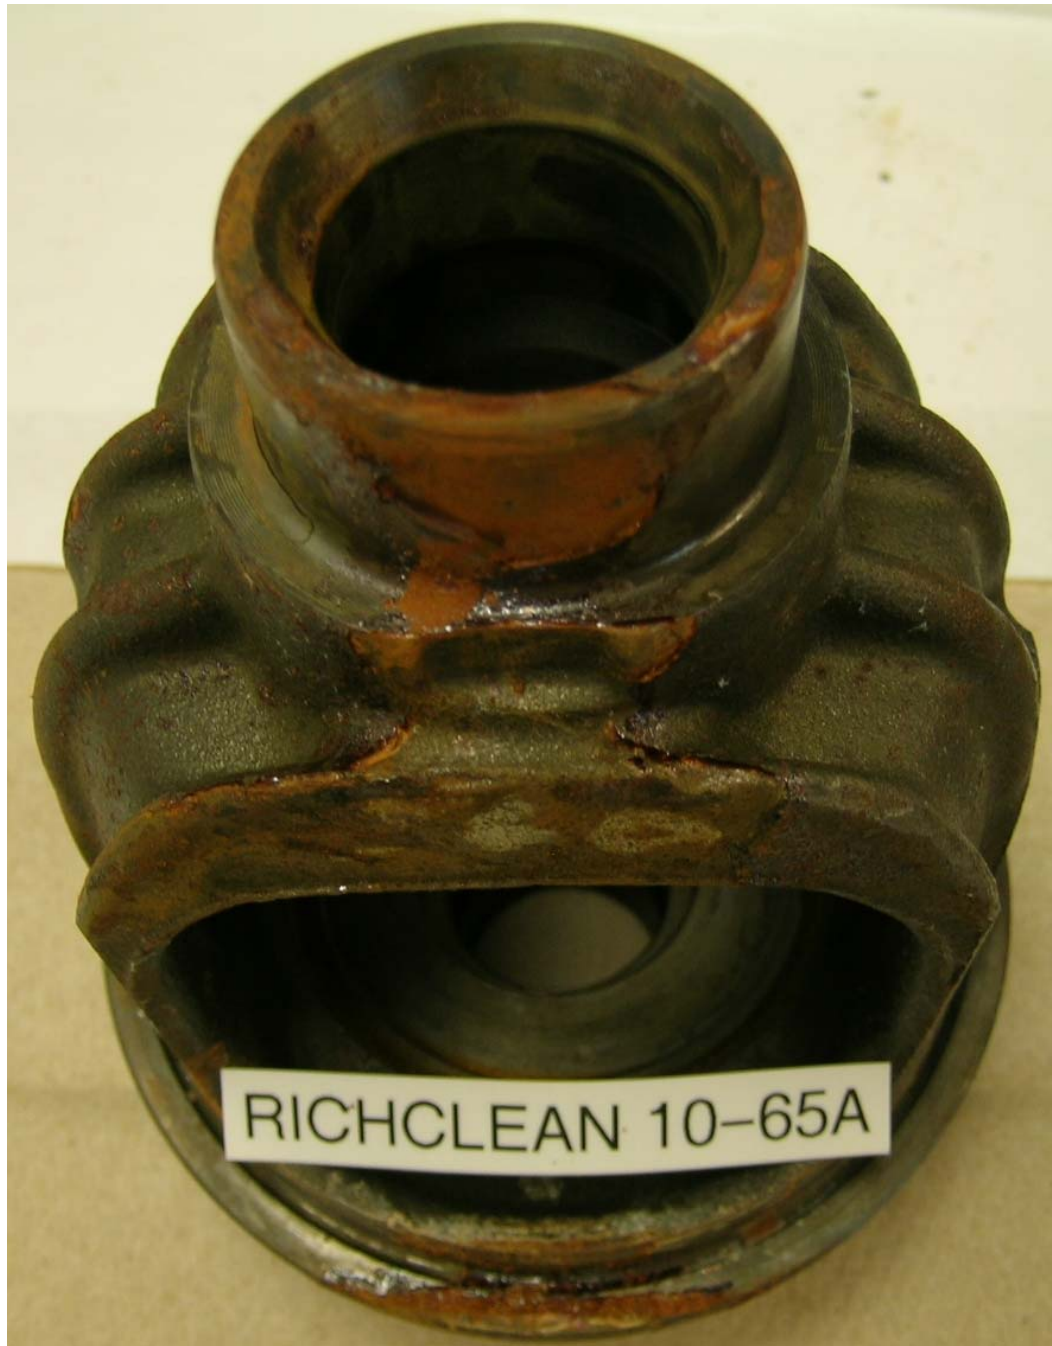
Part dipped in 10% Richclean 10-65A, after 336 hours in ASTM D-1748 humidity cabinet.

- 9) Both cases were removed from VpCI-126 bags, visually inspected, and photographed.
- Results:** The following results were found:
- 1) The case treated with Richclean 10-65A began to corrode after 72 hours. After 336 hours, corrosion was present on greater than 75% of the surface area.

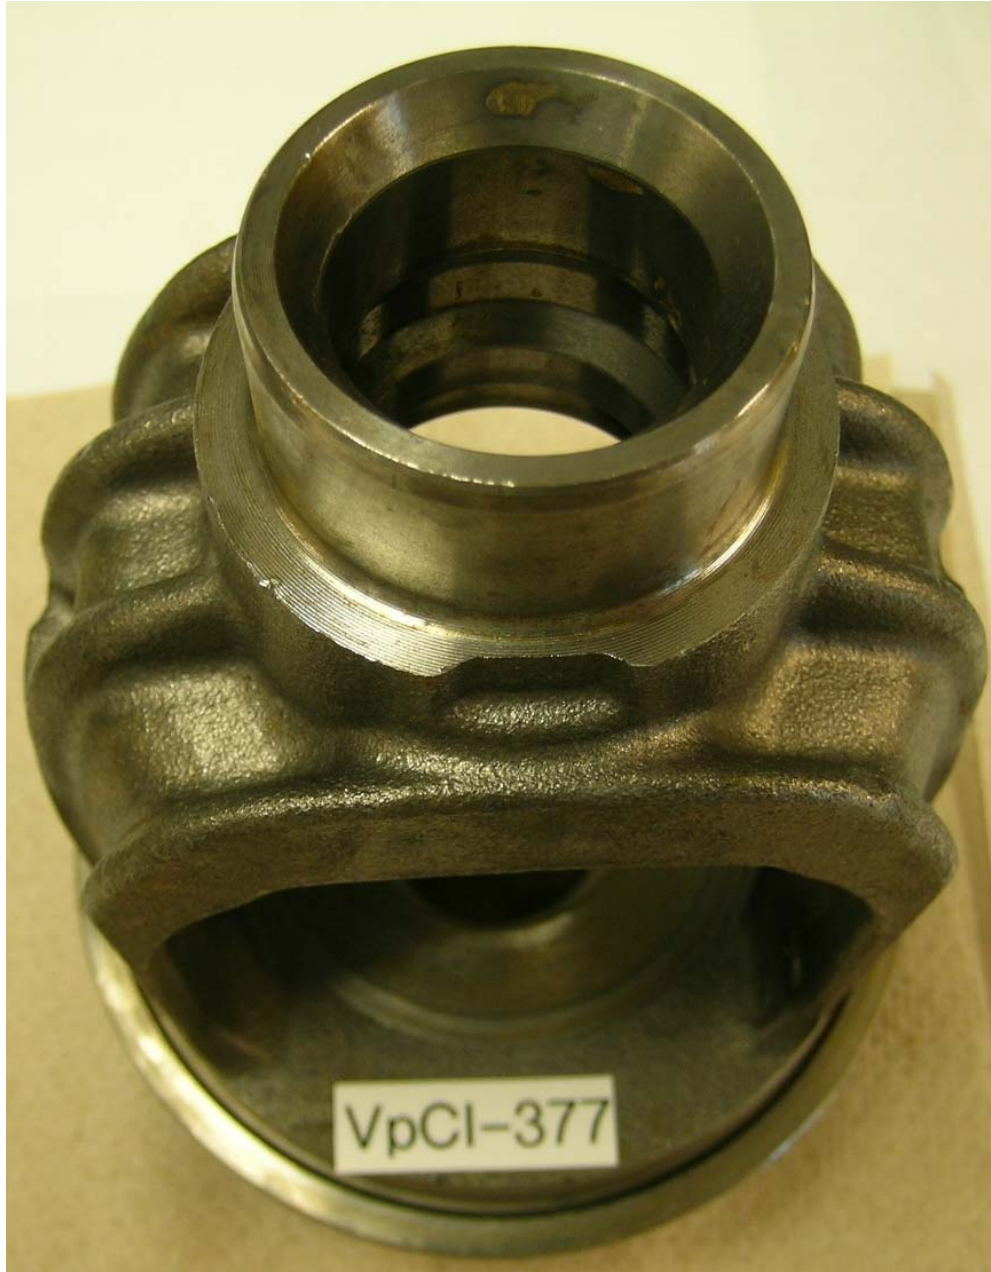
Part dipped in 5% VpCI-377, after 336 hours in ASTM D-1748 humidity cabinet.

- 2) The case treated with VpCI-377 showed a small amount of corrosion after 336 hours. The corrosion present totaled less than 1% of the surface area of the piece, and was located on the underside of the part.
