Evaluation of Process Fluids

Project #: 11-034-1825(bis)

Date: April 4, 2011

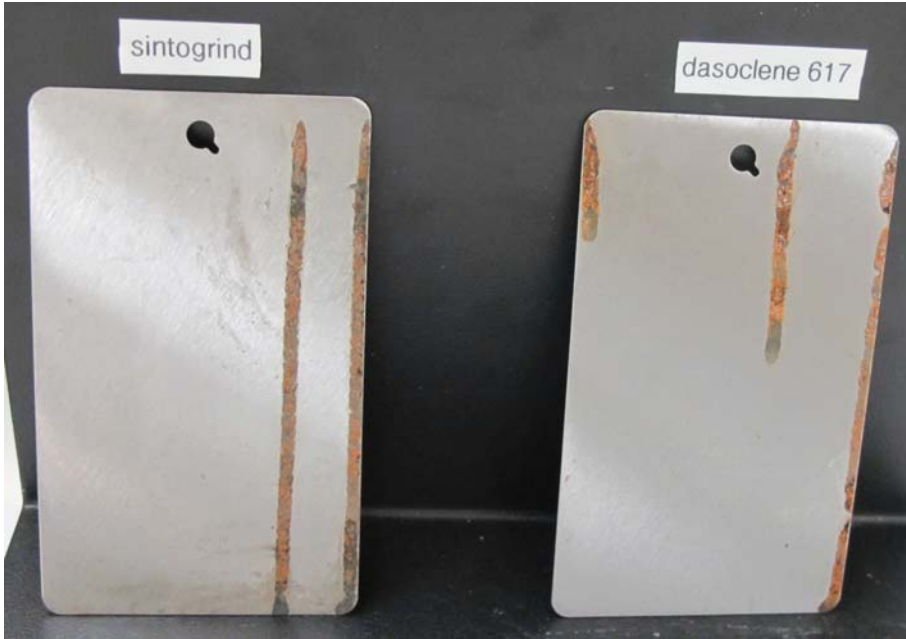
Figure 1. Humidity chamber test results

Sample	Time To Failure
Dascolene 617	144 Hours
Dascolene 598	144 Hours
Sintogrind 353	24 Hours
BioCorr	168 Hours
3% VpCI-347	264 Hours

- 1) Based on the test results, the submitted samples (Dascolene 617, Dascolene 598, and Sintogrind 353) did not provide sufficient corrosion protection.
- 2) The test results determined that using 3% VpCI-347 provided the best corrosion protection, and this could be considered as a replacement for the submitted samples.
- 3) The results for BioCorr determined it lasted longer than the submitted samples.

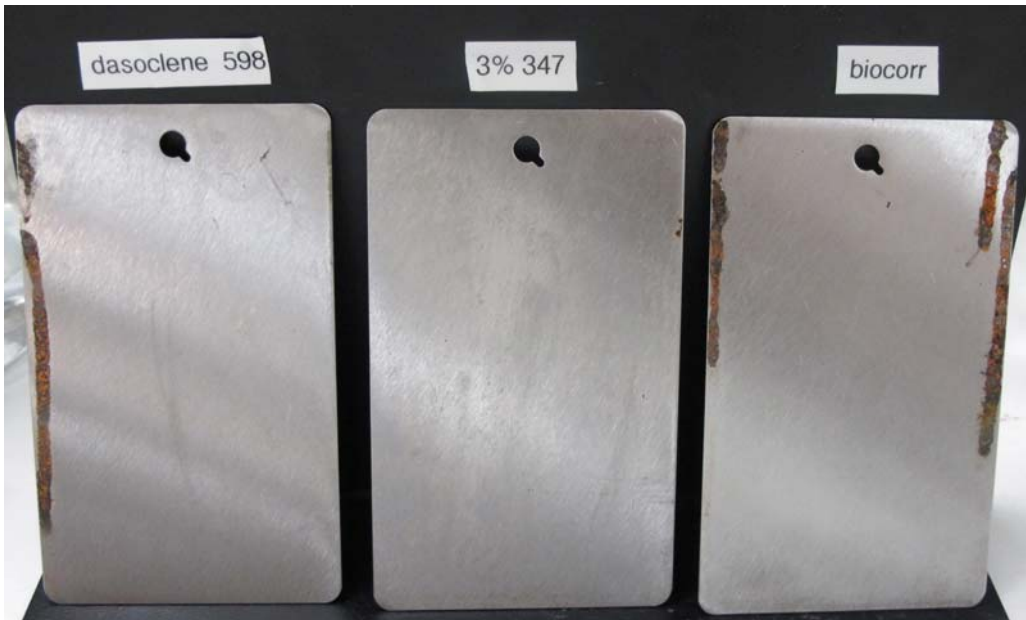
Figure 2. Humidity chamber test results
