Evaluating Liquid Samples

Project #: 11-236-1825(bis)

Background: Liquid samples were sent to Cortec for comparison to similar Cortec products.

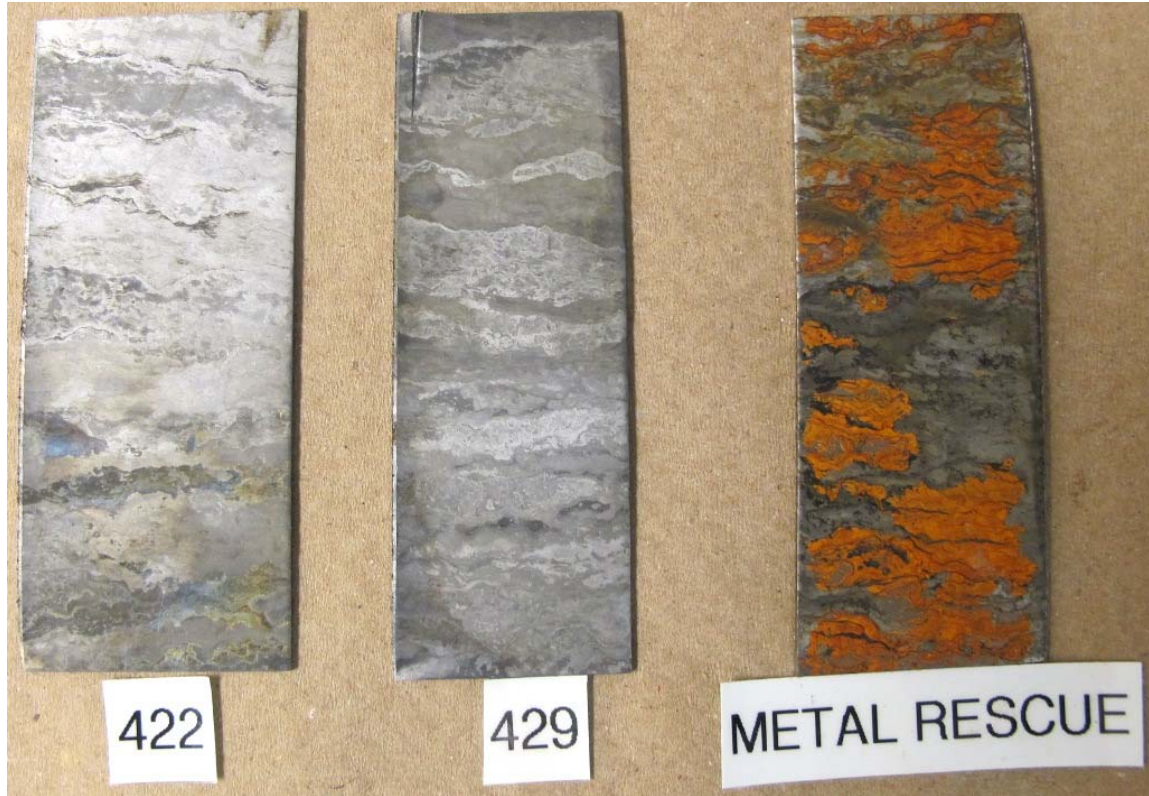
Figure 1: Rust removal products after 2 hours of immersion.

Metal Rescue removed a small amount of corrosion after 2 hours of immersion. VpCI-422 and 429 removed all corrosion from the carbon steel panels.
