*Evaluating Rust Preventive Liquids for
Customer*

Project #: 13-176-1825.bis

Date: October 18, 2013

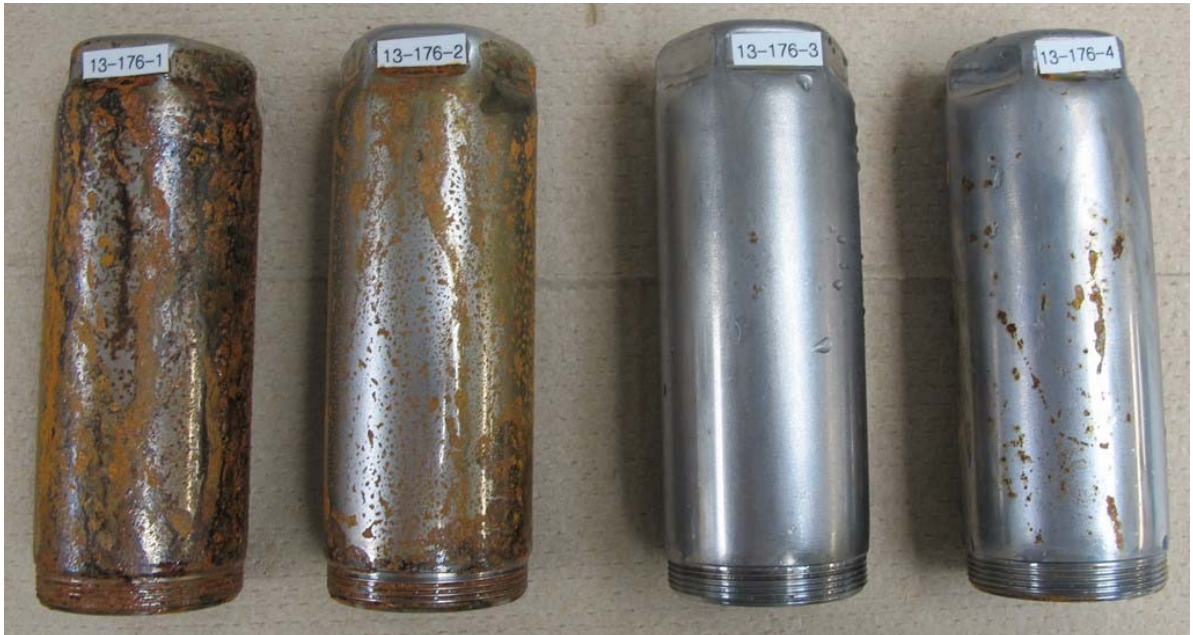
Figure 1: Steel stampings after 500 hours in ASTM D-1735 water fog cabinet. From left to right: Control, Current System, BioCorr, and VpCI-377.

Part Treatment	Time to Corrosion (Hours)
None (Control)	<24
Rust Veto 4240	168
BioCorr	500
VpCI-377 (10%)	408

Interpretations: After 500 hours in ASTM D-1735 water fog testing, BioCorr provided the best corrosion protection, followed by VpCI-377.
